## WELDING INSPECTION REPORT

**OSM Arrival Time:** 700 **Project Name:** SAS Superstructure **OSM Departure Time:** 1900 **Prime Contractor:** American Bridge/Fluor Enterprises, a JV

34-0006 **Bridge No: Component:** OBG components.

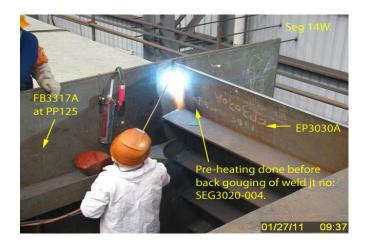
ZPMC personnel doing the fit-up of Deck Panel (DP) 3120A, DP3121A and DP3122A with the Segment / assembly. See attached photo for further information.

This QA Inspector observed ZPMC personnel performing back – gouging on weld no: SEG3020AG-004 at PP125. Pre-heating was observed to be done before performing back gouging. See attached photo for further information.

This QA Inspector observed ZPMC personnel performing assembly / fit-up of Anchorage Plate with the Vertical Sub-Assembly plates. See attached photo for further information.
